DEPARTMENT OF TRANSPORTATION

Contract #: 04-0120F4Cty: SF/ALA Rte: 80 PM: 13.2/13.9File #: 69.28**WELDING INSPECTION REPORT****Resident Engineer:** Pursell, Gary**Address:** 333 Burma Road**City:** Oakland, CA 94607**Report No:** WIR-013253**Date Inspected:** 31-Mar-2010**Project Name:** SAS Superstructure**OSM Arrival Time:** 700**Prime Contractor:** American Bridge/Fluor Enterprises, a JV**OSM Departure Time:** 1900**Contractor:** Zhenhua Port Machinery Company, Ltd (ZPMC), Changxing Island **Location:** Shanghai, China**CWI Name:** Du Zhi Qun**CWI Present:** Yes No**Inspected CWI report:** Yes No N/A**Rod Oven in Use:** Yes No N/A**Electrode to specification:** Yes No N/A**Weld Procedures Followed:** Yes No N/A**Qualified Welders:** Yes No N/A**Verified Joint Fit-up:** Yes No N/A**Approved Drawings:** Yes No N/A**Approved WPS:** Yes No N/A**Delayed / Cancelled:** Yes No N/A**Bridge No:** 34-0006**Component:** Tower**Summary of Items Observed:**

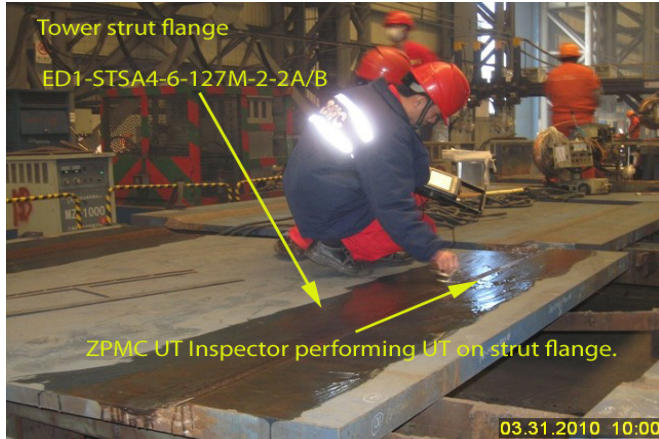
This QA Inspector observed during random Visual inspection ZPMC Ultrasonic Testing (UT) inspector performing UT on Tower strut flange, item identified as ED1-STSA4-6-127M-2-2A/B. For more information see below attached photo.
